#### **BULLETIN: 29009**

## Lower Ball Joint Removal and Installation Issues

Ford Expedition, Explorer, Explorer Sport Trac, F-150, F-150 Heritage, F-250, Ranger / Lincoln Navigator / Mazda B2300, B3000 / Mercury Mountaineer

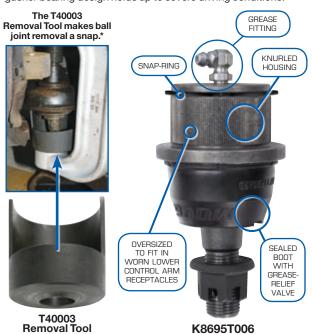
- When installing a replacement ball joint in these applications, technicians may note that the new ball joint may not fit tight in the opening of the lower control arm. The lower ball joint receptacle has been known to experience wear, especially when the ball joint has been replaced several times. If a traditional ball joint is installed in this situation, it will move and shift during operation, which can quickly wear out and damage the control arm, as well as causing unsafe handling issues.
- Lower ball joints in these applications are difficult to press out.
  When removing, an air hammer or chisel is not recommended as it can damage the control arm and the ball joint receptacle.

ENLARGED BALL JOINT RECEPTACLE IN LOWER CONTROL ARM, WHICH CAN CAUSE A LOOSE BALL JOINT FIT

#### MOOG® K8695T006 Oversized Lower Ball Joint

- The ball joint is .006" oversized to fit in worn lower control arm receptacles.
- The snap-ring makes installation easy. The snap-ring in combination with the knurled housing keeps the ball joint securely in place. Use of an appropriate press tool is recommended.
- The greaseable design ensures fresh lubrication reaches the bearing surfaces while flushing contaminants, while the all-metal gusher bearing design holds up to severe driving conditions.
