MOOG

STEERING & SUSPENSION

DID YOU KNOW?

Overview

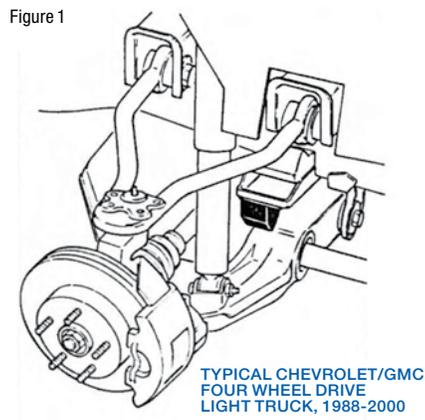
The upper ball joint is a follower ball joint mounted to a bar type control arm (Fig. 1). With the vehicle properly supported, check for perceptible looseness. Whether you find looseness or not, check further to see if there are any contributing causes for failure other than normal wear. If there is suspension damage (as described further on), it may cause a problem in the future.

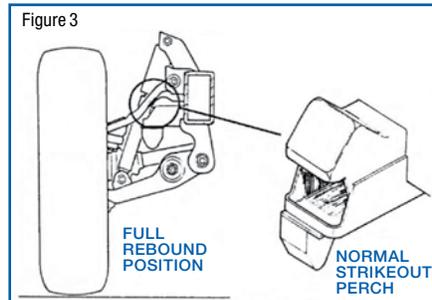
The suspension-limiting device in the rebound direction is the shock absorber. If a longer shock absorber is installed, the bar type arm may introduce undue force on the strikeout perch, and damage may result. If the strikeout perch or shock absorber is damaged in any way, or if the shock absorber allows more suspension travel than the original equipment shock, they must be restored to their original operating condition.

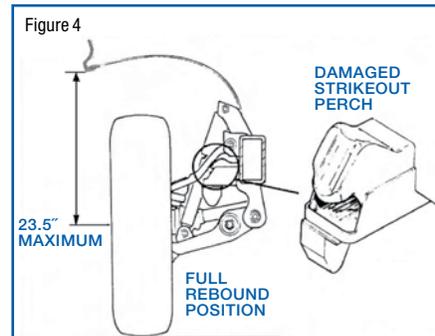
If a strikeout perch shows evidence of sustained contact or damage (Fig. 4), further investigation is required:

- Check the shock absorber for damage and for correct extended length. If the extended length is more than 16.5", the shock absorber must be replaced with a unit that meets OEM specifications.
- Measure as shown in Fig. 4. With the suspension in full rebound, a vehicle with an OEM shock absorber and strikeout perch in good condition will measure 23.5" maximum from the center of the wheel to the underside of the fenderwell.
- Check that the vehicle curb height is correct.
- Check for damage to the upper control arm.

Note: If the above factors are not inspected or corrected, subsequent ball joint failure could result.
