BULLETIN: 25470

Premature wear of socket style sway bar link

1986–2003 Ford,
1986–2001 Mercury, 1988–2001 Lincoln

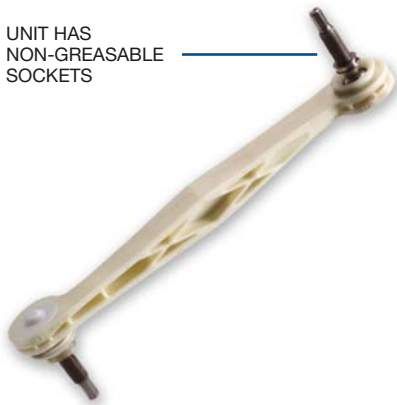
- OE part is a non-greasable, plastic socket design on some Ford, Mercury and Lincoln vehicles. The part is prone to premature wear from intrusion and boot failure. This results in a rattling and clunking noise in the front end.
- Failure may also result from service with use of air guns; wrench flats are inaccessible when using sockets during installation. The friction generated by allowing the stud to spin within the plastic socket may cause irreversible damage.

UNIT HAS
NON-GREASABLE
SOCKETS
