PROBLEM SOLVER™ BULLETIN

BULLETIN: 25474

Premature ball joint wear

Hyundai Accent/Elantra/Tiburon/Sonata

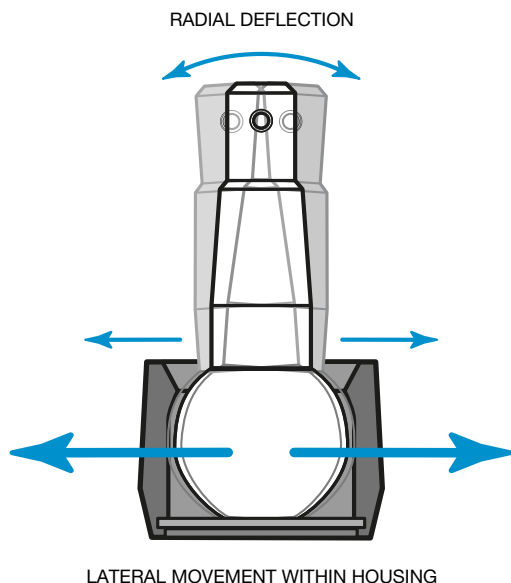
Premature ball joint wear

- Premature ball joint wear is experienced on the Hyundai Accent, Elantra, Tiburon and Sonata.
- Intrusion and boot failure could accelerate ball joint wear.
