PROBLEM SOLVER™ BULLETIN

BULLETIN: 25522

Corroded tie rod adjusting studs 1982-1998 General Motors

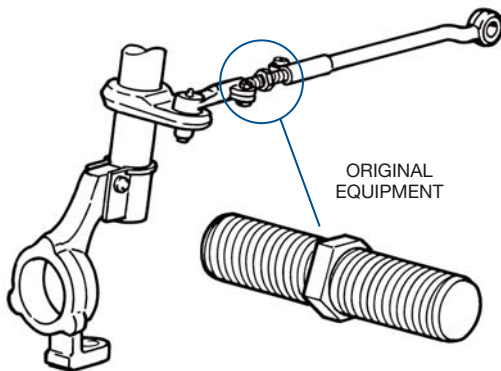
Corroded tie rod adjusting studs

- The corroded tie rod adjusting studs may prevent the ability to set toe and to set a straight steering wheel during alignment.
- Excessive corrosion is common to 2-year and older vehicles.
- Corroded threads will make adjustments difficult or impossible.
- Corrosive effects may make use of existing adjusting stud questionable.
