PROBLEM Solver™ BULLETIN

BULLETIN: 25871

Excessive Play; Joint Separation

1997-1999
Dodge Dakota and Durango

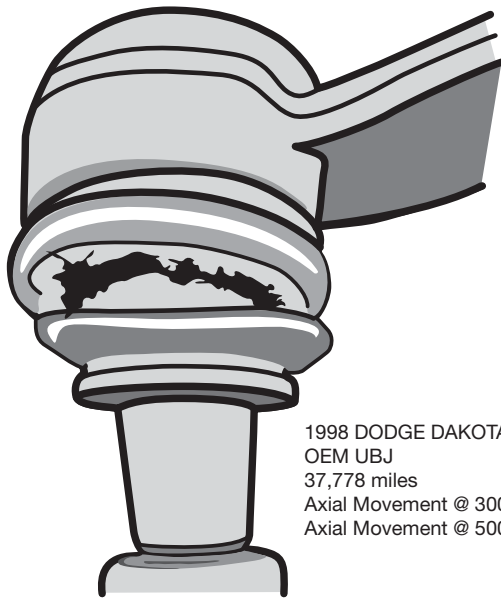
OE Ball Joint Fails Prematurely

- OE ball joints experience boot failure, letting contaminants in and allowing vital lubrication loss.
- Non-serviceable polymer socket design is unable to flush contamination; corrosion and wear quickly set in. (Failed OE Ball Joint problem illustration)

1998 DODGE DAKOTA 4WD
OEM UBJ
37,778 miles
Axial Movement @ 300 lbs = .045"
Axial Movement @ 500 lbs = .048"

MOOG® K7242

- Serviceable MOOG socket design features unique sealed boot technology, with a special grease-relief valve, that prevents contamination.
- Greaseable design.
- Belleville washer pre-load provides lower torque and stud articulation with minimal axial clearance.
- Hardened, powdered-metal bearings are not prone to excessive wear often experienced by plastic bearings under adverse conditions. (Solution illustration)
