PROBLEM Solver™ BULLETIN

BULLETIN: 25931

Front Wheel Drive Lower Ball Joints

General Motors

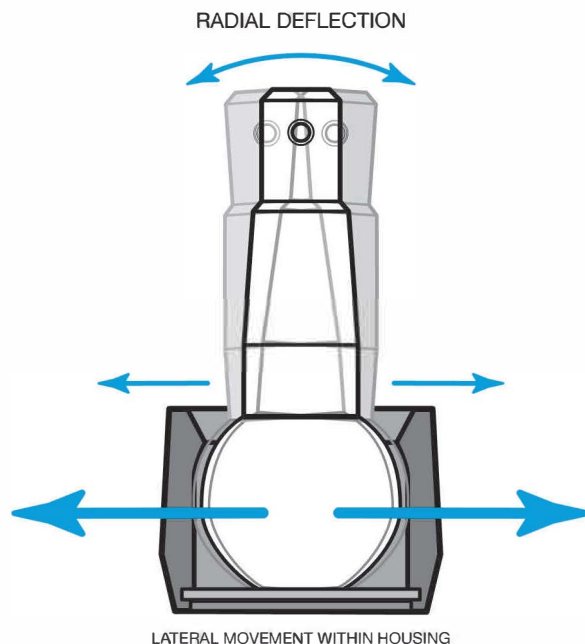
Premature ball joint wear

- Lateral deflection (side to side) loading causes excessive wear in ball joint.
