**BULLETIN: 27008**

## **4WD Twin I-Beam Upper Ball Joint Service**

**Various Ford 28 Series axles**

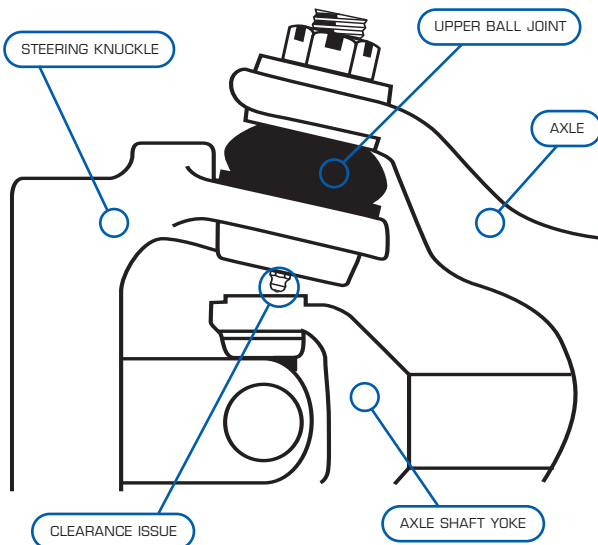
#### **Inaccessible grease fitting**

- Grease fittings on some serviceable ball joints are not accessible for service after ball joint replacement.
- Non-serviceable polymer sockets cannot flush contamination, which quickly leads to corrosion and wear.
- Parts with grease fittings located in the bottom of the ball joint can interfere with the drive axle, resulting in damage.
