PROBLEM Solver™ BULLETIN

Premature Sway Bar Link Failure

Acura/Honda Mid-Size
Coupes and Sedans

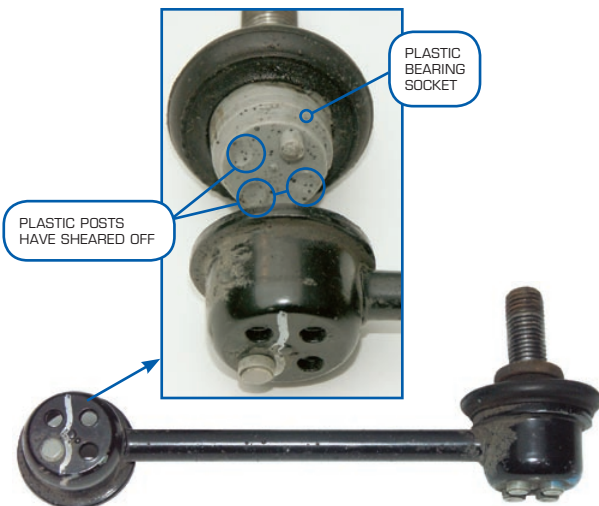
Rattling and clunking from rear of vehicle

- Plastic posts securing the bearing/socket assembly to the metal housing shear off, causing the socket assembly to separate from the link.
- The OE part is a non-serviceable plastic bearing design prone to premature wear.
- The original equipment part lacks wrench flats, making installation and removal more difficult.
