# PROBLEM *Solver*<sup>™</sup> BULLETIN

## Inner Tie Rod Failure

General Motors Full Size Pickup Trucks and SUVs, including Hummer H2

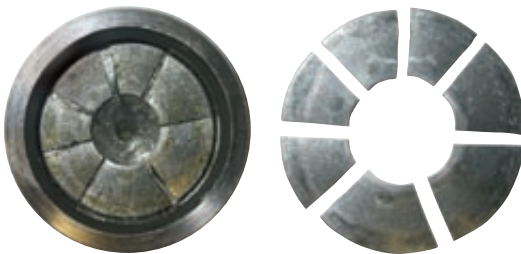
- Application: General Motors full size pickup trucks and SUVs with relay rod and R&P style inner tie rod assemblies.
- Inner tie rod end Belleville preload spring shatters under load. Loss of socket assembly preload causes excessive deflection (sideways "play" or movement), resulting in loose steering, misalignment and poor handling.

A disassembled failed OE part reveals a shattered spring

- Through FEA (Finite Element Analysis) modeling, MOOG® engineers were able to identify housing and spring design issues causing the OE failures. MOOG-specified housing and Belleville washer design eliminates spring bind and shattering during shock load.
- Hardened powdered-metal bearings provide a smooth, durable surface for extended service life.
- Grease grooves in front and rear bearings ensure proper flow of lubrication to bearing surfaces.
