OFFICIAL STEERING & SUSPENSION OF NASCAR®

THE PROBLEM SOLVER®

Clunking/Rattling From Rear Of Vehicle

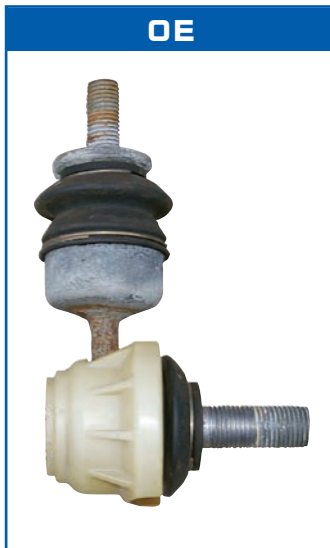
Owners of the popular Mazda 3 may complain of rattling and/or clunking from the rear end of their vehicles. This may be caused by a failed sway bar link.

The OE part is a non-greaseable, plastic socket design and is prone to premature wear. This results in a rattling and clunking noise from the rear of vehicle. Also, the OE replacement part is often damaged during installation: Since wrench flats are not incorporated into the design of the OE replacement part, installers will sometimes use an air wrench to install it. Unfortunately, the friction generated by allowing the stud to spin within the plastic socket may cause irreversible damage.
