UPPER BALL JOINT

GM TRUCKS

BALL JOINT FAILURE DUE TO IMPROPER INSTALLATION

PRESS-IN BALL JOINT APPLICATIONS

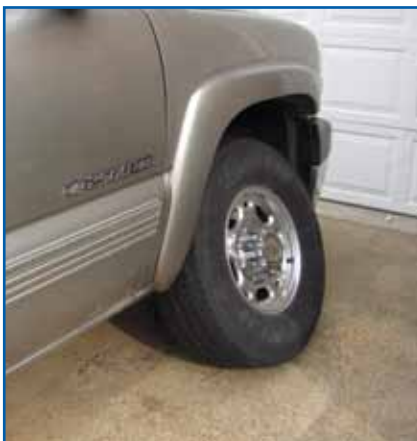
Lack of induction hardening of entire ball stud

The upper ball joint for this vehicle fits a broad range of GVW, including ¾ ton. It is important that the replacement ball joint is designed to meet or exceed OE specification. The OE ball stud is induction hardened. Other suppliers may not induction harden the entire ball stud for this application. This may lead to stud fracture.

RESULT OF FAILED UPPER BALL JOINT

MOOG® Problem Solver® K6696 upper ball joint features a ball stud that is completely induction hardened – including the taper. This provides up to twice the strength of a part that is not entirely treated. In addition, this ball joint features other problem-solving technologies to give it longer service life and dependable operation:

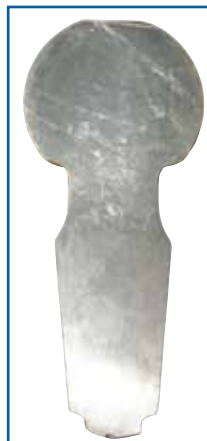
STUD WITH NO INDUCTION HARDENING IS 50% LOWER IN FATIGUE STRENGTH.

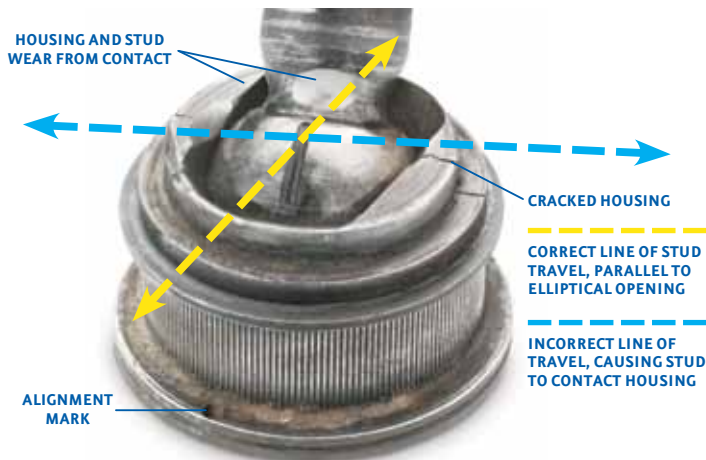
Press-in ball joints on some late-model vehicles are now designed with an elliptical stud opening. Failure to properly align the ball joint in the control arm during installation could result in loss of vehicle control due to ball joint failure.

If an elliptical joint is pressed into the control arm without regard to orientation, it is possible that normal vertical suspension movement will cause the ball joint stud to contact the housing, resulting in stud and/or housing failure.

Elliptical openings are not visible on ball joints with preinstalled boots.

Always look at press-in ball joints for alignment marks such as drilled holes, arrows, punch marks, etc., and follow instructions regarding orientation when installing the joint in the arm. MOOG instruction sheets contain specific information about ball joint orientation where applicable. In addition, MOOG ball joints with elliptical openings have a warning tag on the stud.
