**TOYOTA TRUCKS**

### THE PROBLEM SOLVER®

## Corrosion freezes the camber bolt in place

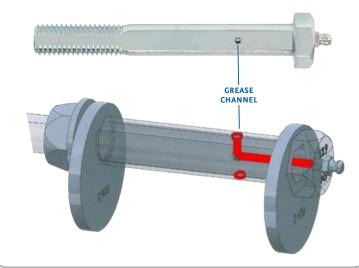
The camber adjustment bolt on lower control arms of certain Toyota trucks is subject to excessive corrosion (especially in the North, where salt is prevalent). The corrosion seizes the bolt and/or sleeve in the bushing, preventing rotation. The seized parts prevent the vehicle from being aligned properly. The process of removing the seized bolt can be difficult and may damage the bushing.

SEIZING OCCURS IN THESE AREAS, CAUSING ISSUES AND PREVENTING ALIGNMENT.

The MOOG® Problem Solver® camber adjustment bolt features a fully greaseable design that prevents corrosion. A grease fitting on one end of the bolt allows grease flow inside. An engineered grease channel in the bolt lets grease flow out and along the interior and exterior of the sleeve to keep the bolt and sleeve lubricated. With these features enabling regular maintenance, the MOOG camber adjustment bolt will remain adjustable even after many miles of service in harsh conditions.
