OFFICIAL STEERING & SUSPENSION OF NASCAR®

THE PROBLEM SOLVER®

Lower ball joint not available from OE dealer

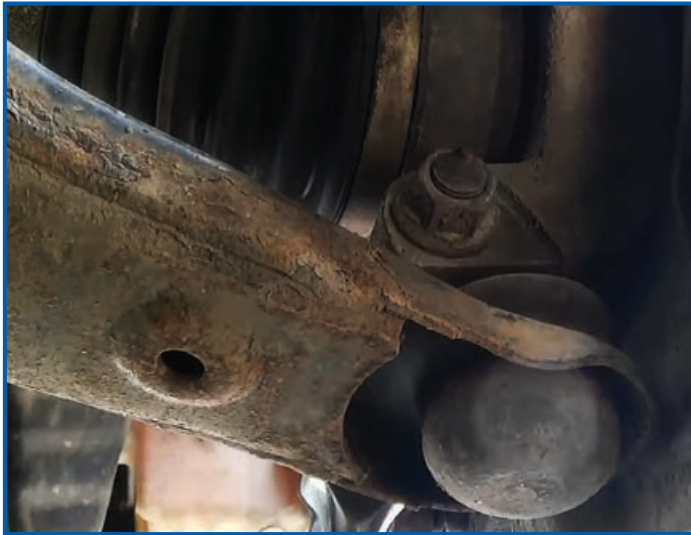
The 2002-2006 Mitsubishi Lancer utilizes lower control arms with a pressed-in ball joint. The service manual does not include a provision for replacing the ball joint, just servicing the boot if torn. This is because the lower ball joint on these vehicles is not available as an OE-replacement part. If the ball joint has failed, it requires replacement of the entire control arm. In addition, the OE control arm includes a non-serviceable ball joint.

MOOG® Problem Solver® K80373 lower ball joint

The MOOG® Problem Solver® K80373 ball joint provides technicians with a premium alternative to replacing the lower control arm. This specially engineered component features a knurled housing and snap ring for ease of installation and secure mounting.

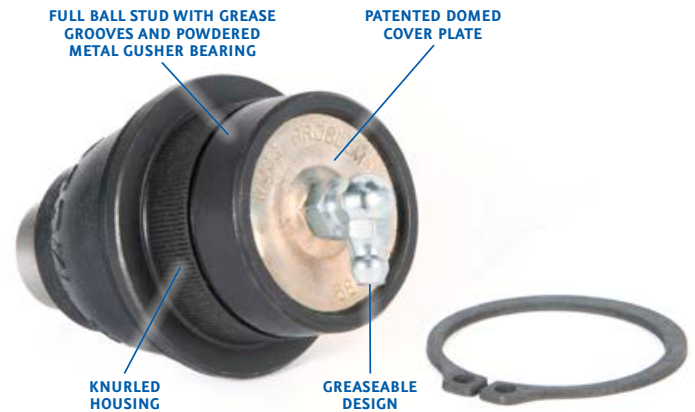
Note: The OE ball joint is crimped into the lower control arm.

OE ball joint is removed from the control arm in this direction.

Removal: Press down and out of control arm with a suitable press tool.

Installation: The MOOG K80373 is pressed into the control arm from the same side.

MOOG ball joint is installed in the control arm in the same direction as the OE ball joint was removed.
