## LOWER BALL JOINT FAILURE

CHEVROLET TRAILBLAZER, GMC ENVOY, OLDSMOBILE BRAVADA, BUICK RAINIER, SAAB 9-7X AND ISUZU ASCENDER

## THE PROBLEM SOLVER®

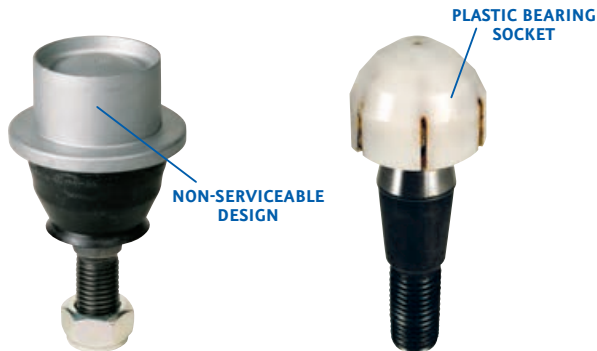
#### Lower Ball Joints Fail Prematurely

- Original equipment stud ball diameter and OE-style polymer bearing do not provide sufficient load-carrying capability, especially in rough service conditions.
- Non-serviceable polymer sockets cannot flush contamination, which quickly leads to corrosion and wear.
- Load stress and intrusion quickly erode the bearing surface.
- OE-style replacement ball joints require special tools during installation to flare the retention flange

Be sure to remove old OE-style ball joint flange. It must be bent upward for removal.
