PREMATURE WEAR OF UPPER BALL JOINT

DODGE RAM 2500/3500 4WD,
RAM 1500 W/MEGA CAB

THE PROBLEM SOLVER®

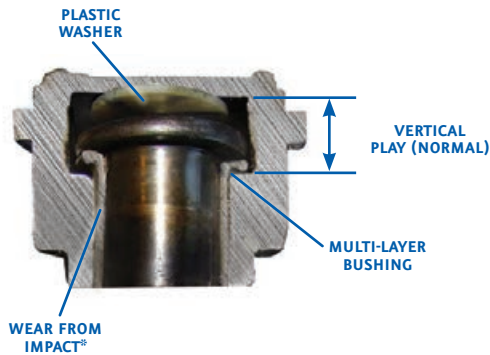
Premature ball joint failures on many late-model Ram trucks are a common occurrence on vehicles equipped with the 9.25" axle. The installation process puts significant demands on the upper ball joint bowl design. The upper and lower ball joints on these axles may not be perfectly aligned. The OE ball joint design deforms to comply to these demands. This leads to severe wear from impact loads occurring under "normal" driving conditions. The ball joints should be replaced any time there is side-to-side or back-and-forth "radial play" (vertical-only movement is normal).

OE DESIGN IS NON-SERVICEABLE

*REPLACE WHEN THERE IS MOVEMENT SIDE-TO-SIDE
