THE PROBLEM SOLVER®

DID ■ YOU ■ KNOW?

The lower control arm vertical bushing on the vehicles listed is prone to splitting and failure. Drivers will experience excessive front end noise and clunking. MOOG recommends replacement with part number K6698. This bushing is designed to work with both aluminum and stamped steel control arms. When replacing the bushing with MOOG K6698, technicians may note a difference in appearance. This is because the OE part may contain voids, or air gaps, which are prone to failure because the rubber bushing separates from the outer metal ring. The MOOG K6698 is made of solid material, increasing life.

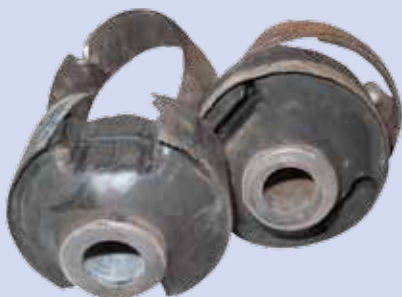
Metal outer ring separated from rubber bushing

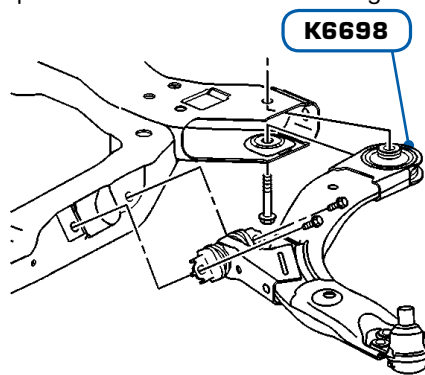
The figure below shows the placement of the vertical bushing.

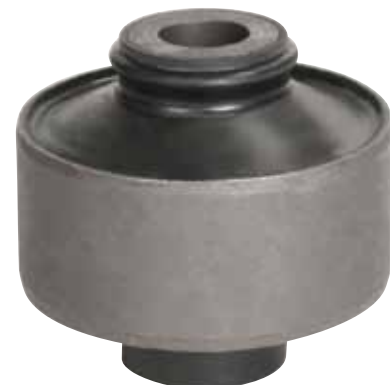
1. Place the MOOG K6698 bushing to the tapered side of control arm.

2. Using a suitable press tool, install the control arm bushing in the lower control arm.
3. Install the bushing to the same depth as noted during removal.
4. Install the lower control arm.
