THE PROBLEM SOLVER®

FRONT LOWER BALL JOINT

2007-2012 NISSAN SENTRA

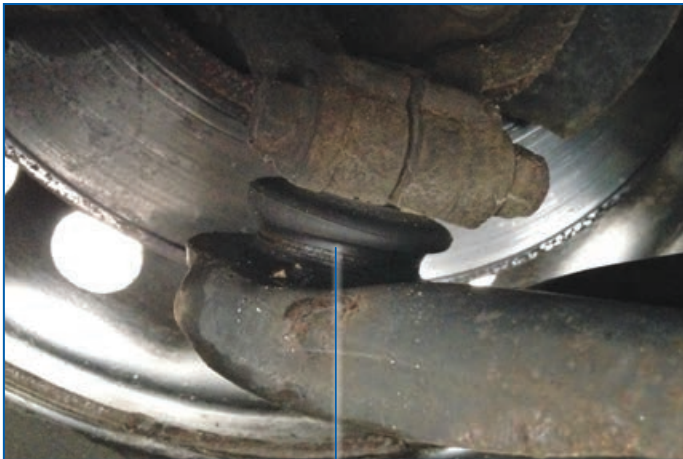
OE dealers do not offer a replacement front lower ball joint by itself. So to replace the lower ball joint, installers must purchase the entire control arm.

REPLACEABLE PART.
REPLACE WITH MOOG® PROBLEM SOLVER® K500223 LOWER BALL JOINT.

MOOG® Problem Solver® K500223 Lower Ball Joint

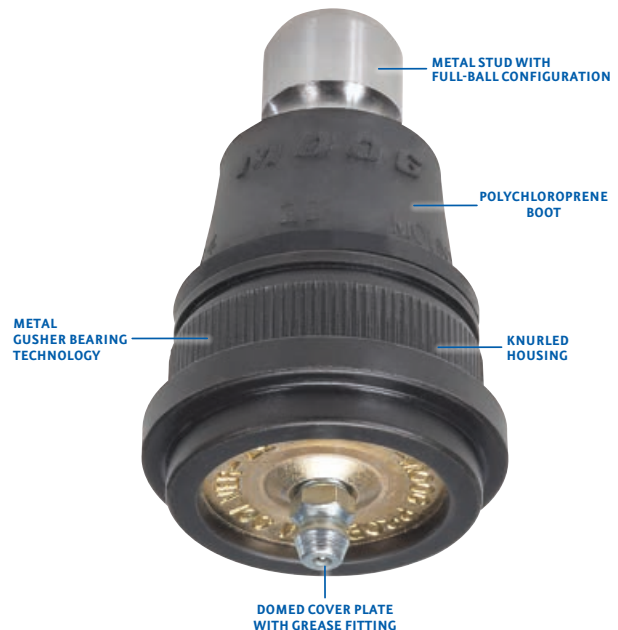
MOOG® Problem Solver® ball joint K500223 is the perfect replacement for the failed control arm ball joint. The knurled housing enables it to fit securely into the control arm. The K500223 design, which incorporates an all-metal gusher bearing and full-ball stud, is both smooth and durable.

- All-metal “gusher” bearing design provides strength and allows lubricant to penetrate bearing surfaces for longer life.
- Greaseable design flushes contamination and keeps part lubricated.
- MOOG patented domed cover plate and Belleville washer ensure proper preload and consistent socket torque for the life of the part.
- Metal stud with full-ball configuration provides smooth, even rotational movement.
- MOOG “grease relief” polychloroprene boot lasts longer and directs contaminants out of the socket and away from brake components during lubrication.
