PROBLEM *Solver*[®] BULLETIN

Rear Transverse Spring Isolator Pads

GM Front-Drive
W-Body 1988-1997

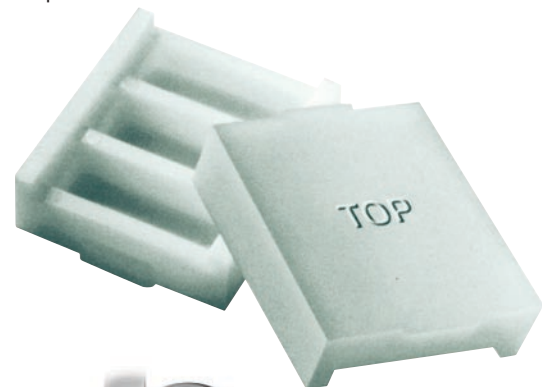
MOOG ISOLATOR PAD INSTALLS INTO THE POCKET OF THE SPINDLE/KNUCKLE.

- Constructed of long-lasting composite materials.
- Eliminates squeaking and clunking noises in the rear suspension.
- Extends the life of GM W-Body transverse springs and supporting components. Prevents costly replacement of entire transverse spring if symptoms are caught early.
- Prevents costly replacement or repairs to the spindle rods and other suspension components. Saves time and money for you and your customer.
- Easy to install: Remove the excess rubber of the OE pad from the spring. Insert the MOOG Isolator Pad into the pocket area of the spindle, positioning it just like the OE pad. The spring can be placed on top of the isolator pad within the spindle.
