BULLETIN: 25959

## Lower Ball Joints

1995–2004

Ford Taurus, Mercury Sable, Lincoln Continental

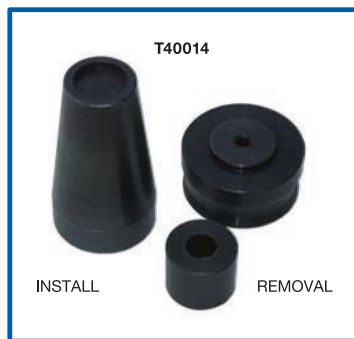
#### Corroded ball joints are difficult to remove

- Failed ball joints can be difficult to remove because of corrosion.
- Mating surfaces of the aluminum OE knuckle and ball joint housing promote corrosion, making it difficult to press out the worn ball joint.

**Inspection Tip:** Typical inspection procedures may not reveal worn lower ball joints. Rocking the tires at the 3 and 9 o'clock positions may reveal ball joint play that was not evident using normal inspection procedures.

- The MOOG K8687 and T40014 provide a complete repair solution for Taurus, Sable and Continental worn ball joints.
- The MOOG premium K8687 zinc-plated housing helps prevent galvanic corrosion between the aluminum knuckle and ball joint housing.
- The MOOG T40014 easily and safely removes worn ball joints while preventing knuckle damage due to improper service procedures. *(Do not apply heat to the aluminum knuckle in an attempt to remove the ball joint.)*

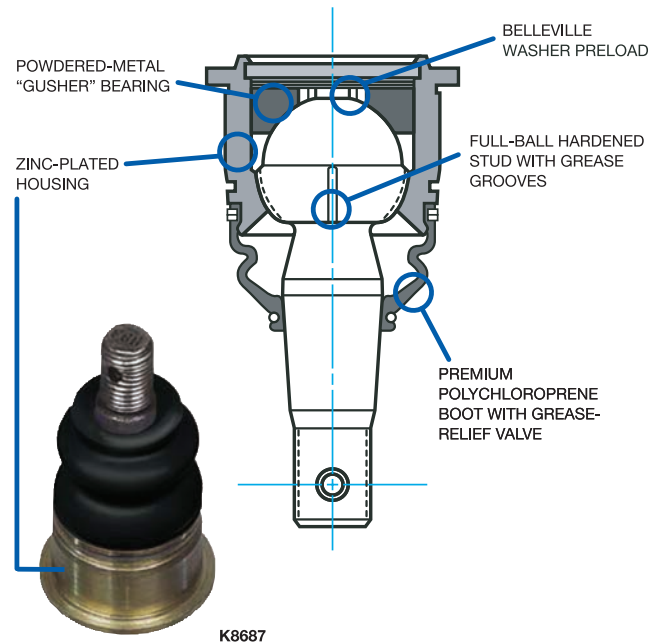
#### MOOG® complete ball joint repair solution
