**PREMATURE SWAY BAR LINK WEAR**

**THE PROBLEM SOLVER®**

2000-2010 FORD FOCUS

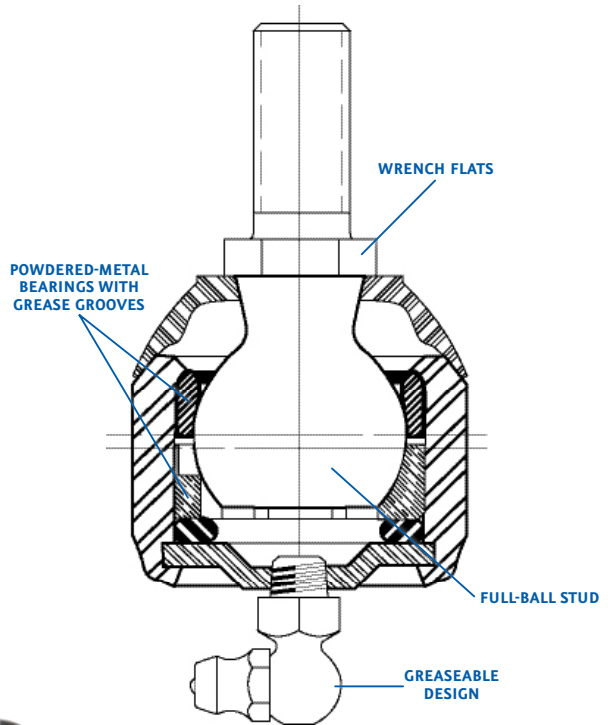
- MOOG's durable powdered-metal "gusher" bearing design keeps lubrication at the bearing surface, reducing friction, for longer life.
- Greaseable design flushes contamination.
- Wrench flats at the base of the stud allow for a positive hold and the use of sockets, for quick and easy installation and removal.
