CHECKING STUD TAPER FITMENT

All Makes and Models

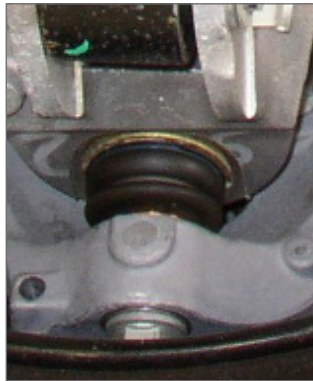
MANY CHASSIS PARTS USE A TAPERED STUD THAT SEATS IN A TAPERED HOLE TO ENSURE A SECURE FIT AND PRECISE ALIGNMENT

with other steering and suspension components. When replacing any component with a tapered stud, both the stud on the old part and the tapered hole it seats in should be inspected for signs of improper fitment, wear (distortion) and/or damage.

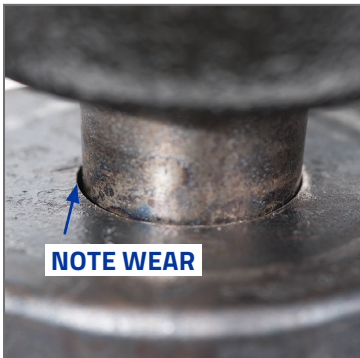
The primary reason for taper wear and distortion is over or under torquing the stud. Wear of the tapered hole can also occur if there are multiple disconnections and reconnections. This wear is more dramatic on aluminum knuckles.

Preventing taper wear is simple. Always inspect old parts and the components they attach to for wear and damage, and replace all components necessary for a proper repair. Follow the procedures and specifications outlined in the vehicle's repair manual to ensure parts are installed correctly and all hardware is torqued to spec.
