LOWER BALL JOINT PE-BJ-3322

Citroën C5 : 2008 - 2017
Peugeot 407 : 2004 - 2011

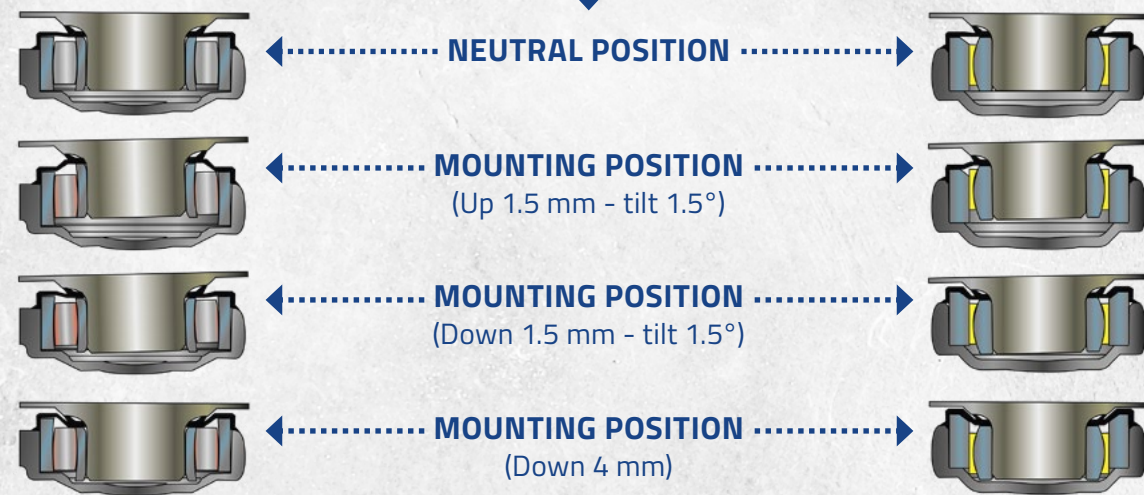
With the OE part/design, the rolling elements are repositioning themselves in order to compensate for an inaccurate mounting position. This can cause the bearing to work under compromised operating conditions, resulting in a downgraded performance and excessive wear.

MOOG's patented system however allows a fully straight slide of the plastic bearing within the outer tube, **ensuring a perfect fit, function and maximum durability** at all times.

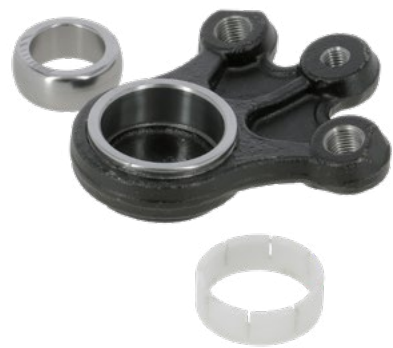
New MOOG PE-BJ-3322 designed and tested to fit both new and old knuckle pin designs. PE-BJ-13251 has been superseded by PE-BJ-3322. The additional dust boot cover that comes with PE-BJ-3322 is not required for vehicles as of 04/12/2006

- ① Triple lip sealing dust boot for **improved contamination resistance.**
- ② Ball joint is pre-greased to **reduce wear** and serve as a **moisture barrier.**
- ③ Premium housing coating to **resist corrosion.**

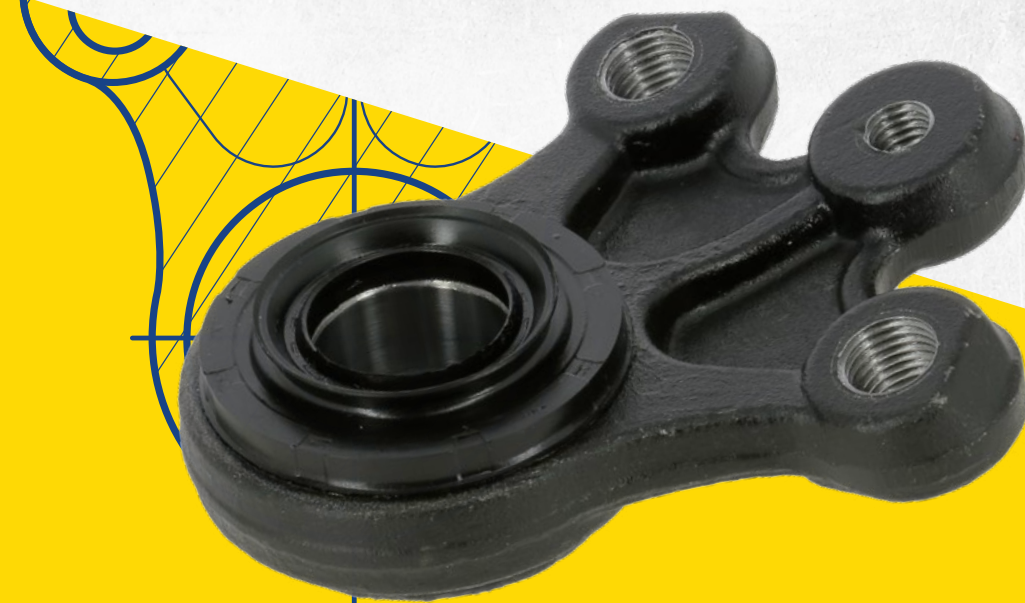
COMPETITION

LIMITED DURABILITY
&
EXPENSIVE REPAIR

OE design also widely used in the aftermarket

Damage may be caused by the pressing operation due to metal to metal contact, highly sensitive to incorrect installation

Sealing performance may cause corrosion and premature failure

Competition is recommending full replacement of the knuckle including wheel hub and bearing

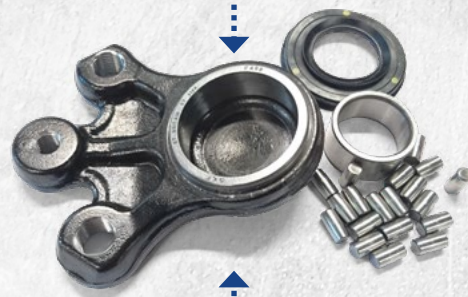
LOWER BALL JOINT ACTS AS A PIVOT ENABLING AXIAL ROTATION.

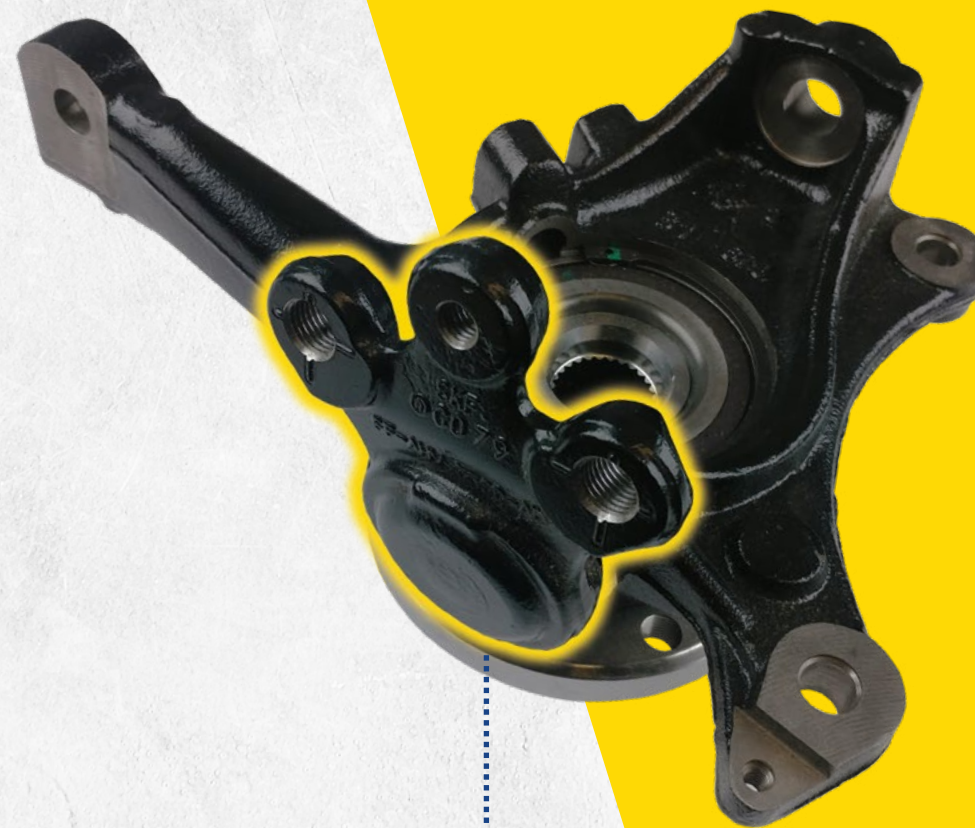
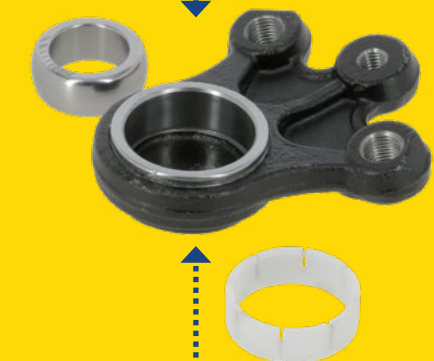
PE-BJ-3322

MOOG SOLUTION

BETTER DURABILITY
&
VALUE FOR MONEY REPAIR

MOOG patented* problem solving design

Consist of an inner and outer ring with a plastic bearing. Installation damage caused by metal to metal contact is eliminated

Triple lip sealing dust boot guarentees an improved sealing performance

No replacement of the full knuckle

A perfect fit, function and maximum durability
