# Problem Solver Bulletin: 216004

## K3185 LOWER BALL JOINT

1999-2015 JEEP VEHICLES

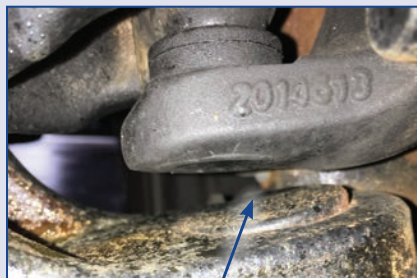
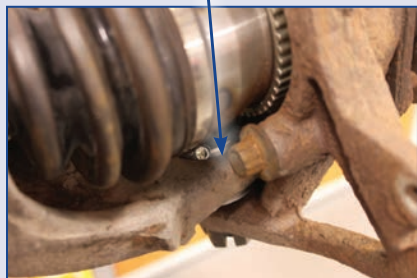
The OE front lower ball joint is not serviceable and is prone to premature failure. The proximity of the axleshaft to the lower ball joint prevents the inclusion of a typical grease fitting. Also, its non-serviceable design allows dirt and other contaminants to remain in the ball joint, causing wear.

NOTE TIGHT CLEARANCES

The MOOG® K3185 lower ball joint features a flush, angled grease passage that allows the ball joint to be positioned for easy access for greasing with a needle nozzle adaptor such as the Lincoln #5803 or similar.

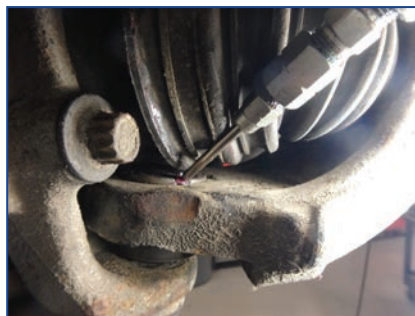
A needle nozzle adaptor can be used to grease this MOOG ball joint.
