UPPER BALL JOINT

GM TRUCKS

BALL JOINT FAILURE DUE TO IMPROPER INSTALLATION

PRESS-IN BALL JOINT APPLICATIONS

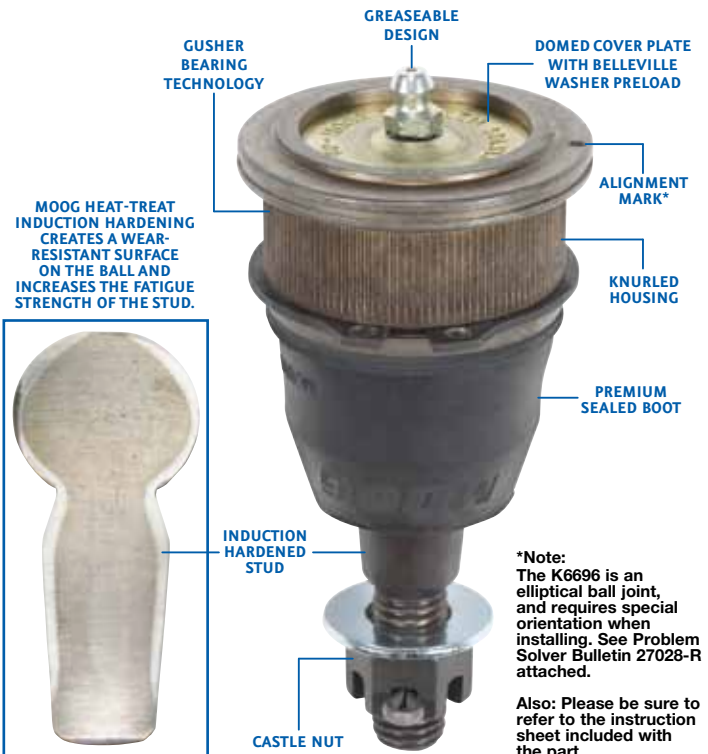
MOOG® Problem Solver® K6696 Upper Ball Joint

MOOG® Problem Solver® K6696 upper ball joint features a ball stud that is completely induction hardened – including the taper. This provides up to twice the strength of a part that is not entirely treated. In addition, this ball joint features other problem-solving technologies to give it longer service life and dependable operation:

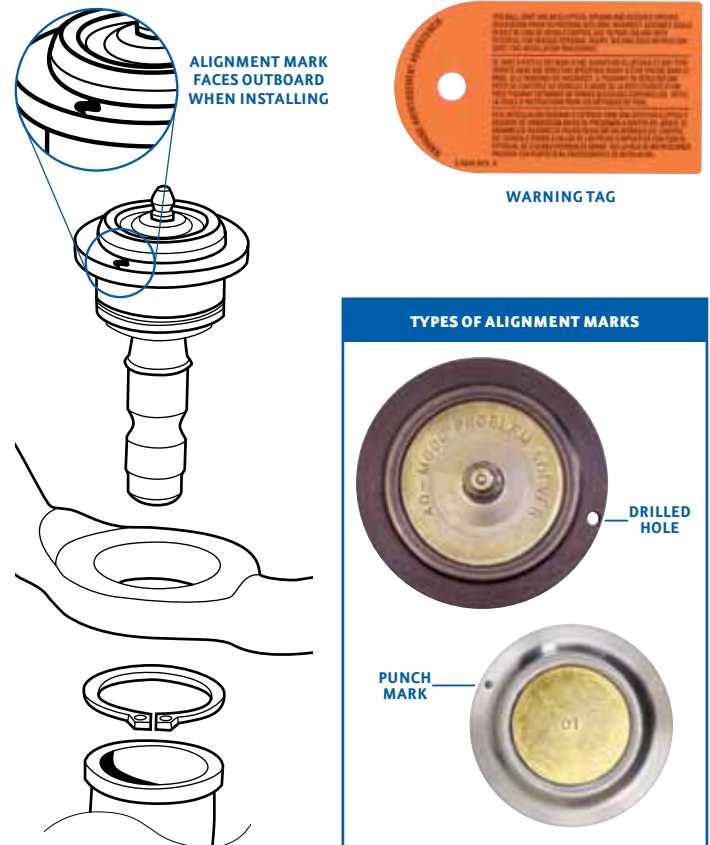
Press-in ball joints on some late-model vehicles are now designed with an elliptical stud opening. Failure to properly align the ball joint in the control arm during installation could result in loss of vehicle control due to ball joint failure.

If an elliptical joint is pressed into the control arm without regard to orientation, it is possible that normal vertical suspension movement will cause the ball joint stud to contact the housing, resulting in stud and/or housing failure.

Always look at press-in ball joints for alignment marks such as drilled holes, arrows, punch marks, etc., and follow instructions regarding orientation when installing the joint in the arm. MOOG instruction sheets contain specific information about ball joint orientation where applicable. In addition, MOOG ball joints with elliptical openings have a warning tag on the stud.
