DID YOU KNOW?

ADVICE FOR THE PROFESSIONAL

Situation

Late-model GM and Dodge/Ram trucks use different axles and driveshafts manufactured by either Dana (Spicer) or American Axle & Manufacturing (AAM). The particular driveshaft installed in the affected vehicle is determined by box/cab configuration, transmission, bed length and vehicle options. Each of these driveshafts requires a specific u-joint part number. To correctly determine the exact u-joint part number, care must be taken when looking up an application in the MOOG® catalog.

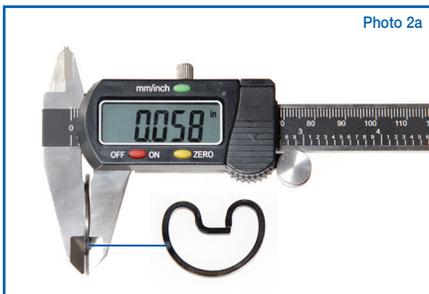
Photo 2a

The MOOG catalog contains all details necessary to identify and select the proper u-joint. As mentioned previously, the year, make and model of the vehicle are not enough to ensure correct fitment. Bed length, cab size, driveshaft/yoke configuration, transmission, vehicle option packages and more can affect the u-joint selection. The proper u-joint for the application can be found in the MOOG catalog under the appropriate listing (see example).
