PROBLEM *Solver* BULLETIN

Rear Suspension Pivot Bushing Failure

GM Crossovers
and Minivans

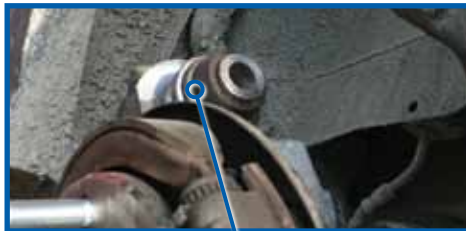
PIVOT BUSHING

GM crossover and minivan rear aluminum suspensions use a "cross-axis" pivot bushing which is pressed into the upper axle/hub carrier (or knuckle). This pivot bushing takes the place of an upper ball joint. The OE part may experience early failure, creating rear alignment change which can lead to excessive tire wear. In addition, this part is not available separately from the dealer. If the bushing is worn or failed, the entire axle/hub carrier must be replaced.

Cross axis pivot bushing unassembled

The MOOG K200174 and MOOG K200175 pivot bushings correct the looseness and restore alignment integrity. The lower pivot bushing K200175 is a companion part suggested to be changed when the upper pivot bushing is replaced. Since these parts are available separately, the OE axle/hub carrier (knuckle) can be retained.
