# PROBLEM Solver™ BULLETIN

BULLETIN: 25678

## Hammering noise from front end 1995-2001 Chrysler, Dodge, Plymouth

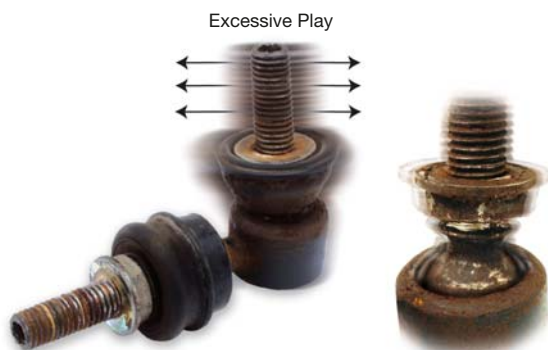
#### Hammering noise from the front end

- The polymer design of the OE front stabilizer bar link for mid-size Chrysler, Dodge and Plymouth vehicles is not durable enough to withstand normal demands. Combined with a non-greaseable design that cannot flush out contaminants, the result is premature failure causing a hammering noise in the front end.

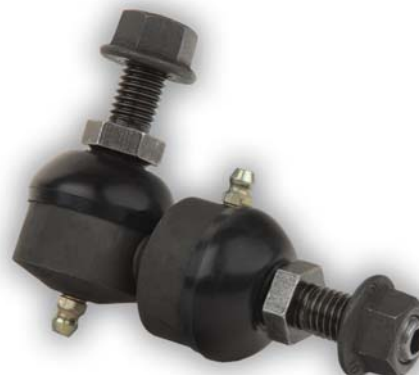
#### MOOG® K7306 stabilizer bar link kit with a greaseable design

- All-metal construction is more durable and not prone to OE-plastic design failure, delivering the performance expectations for the application.
- Greaseable design flushes out any possible contamination.
- Full ball stud provides 360° of smooth, even, rotational movement.
- All-metal "gusher" bearing design allows lubricant to penetrate bearing surfaces for longer life and reduced steering effort.
- Wrench flats and Allen head in stud for ease of installation.
