BULLETIN: 25953

Front Coil Springs Breaking

1998–2000 Ford Contour and Mercury Mystique

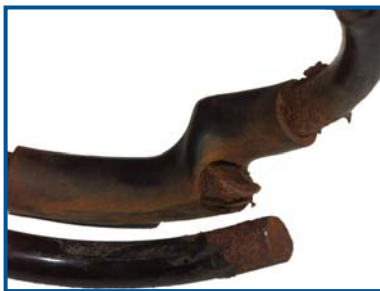
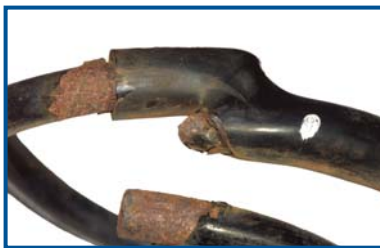
Front Coil Springs Breaking

- Front coil springs for the Ford Contour and the Mercury Mystique from 1998 to 2000 could potentially fracture due to corrosion and fatigue. Tires can be punctured by coming in contact with a broken spring.

- MOOG offers a replacement, constant rate coil spring that is designed to provide more strength and durability.
- Creates lower stress throughout the spring to resist fatigue due to a larger diameter bar and a higher spring rate.
- Incorporates a shorter free height.
- Resists corrosion with an improved, coated material.
- Resists spring clash with a plastic sleeve.
- Tougher spring provides a firmer ride for better handling.
