PROBLEM *Solver*[™] BULLETIN

Front Coil Spring Failure

2000-2007
Ford Focus

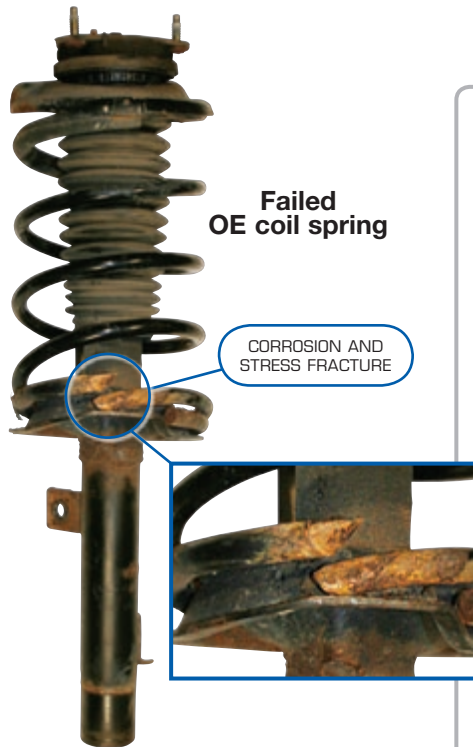
Stress and corrosion can cause front coil springs to fracture and fail, resulting in suspension noise and sagging.

Failed
OE coil spring

CORROSION AND
STRESS FRACTURE

MOOG offers a replacement constant rate coil spring designed to provide more strength and durability:

- Larger diameter bar and additional coils reduce stress throughout the spring to combat fatigue.
- Improved coated material resists corrosion.

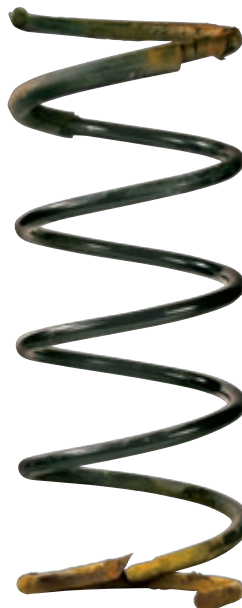
OE coil spring

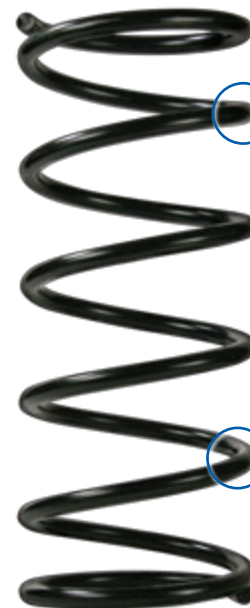
MOOG coil spring
80170

ADDITIONAL COILS
REDUCE STRESS

COATED MATERIAL
RESISTS CORROSION
