PROBLEM *Solver*[®] BULLETIN

Failing Parts on OE Strut Mounts

Chrysler Sebring Sedan
2001-2006, Dodge Stratus
Sedan 2001-2006

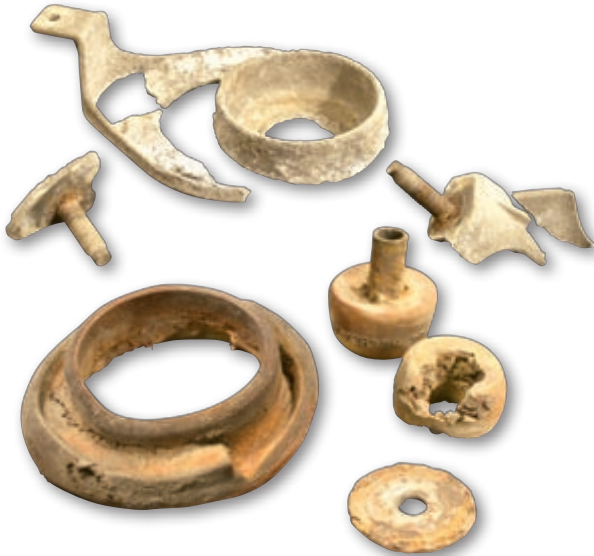
Corrosion and failure of OE strut mount

Customers may complain of loud clunking and banging noise from rear strut mount area/trunk. Be sure to inspect the upper rear strut mount on these vehicles. In some cases, these mounts have completely disintegrated due to the galvanic corrosion of the cast aluminum body. Also, the rubber spring seat insulator will most likely be torn or damaged, requiring replacement.

Featured above is the actual part removed from a 2002 Dodge Stratus. Galvanic corrosion on the OE Strut Mount has caused complete component failure.

MOOG® K160051 Strut Mount

The MOOG K160051 features an electro-plate, corrosion-resistant coating to help prevent galvanic corrosion. For ease of installation and to eliminate noise issues, the unit includes a new spring seat insulator and new installation hardware.
