**THE PROBLEM SOLVER®**

**ABS sensor issues due to abrasion**

**MOOG® application-specific abrasion-resistant ABS cord**

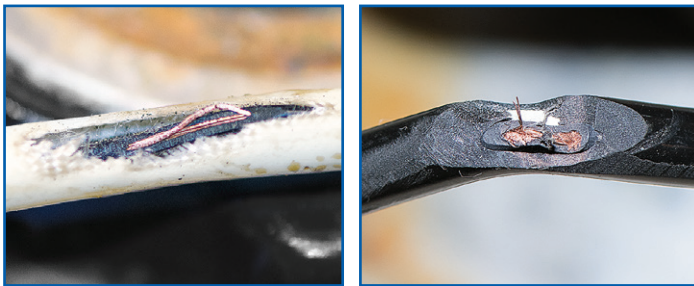
ABS sensor failure is among the most common causes of ABS signal problems on hub assemblies. Abrasion of the sensor wire creates signal faults that can only be resolved by replacing the hub. Many ABS cords are made of fiber or rubber, which tend to be susceptible to abrasion or moisture.

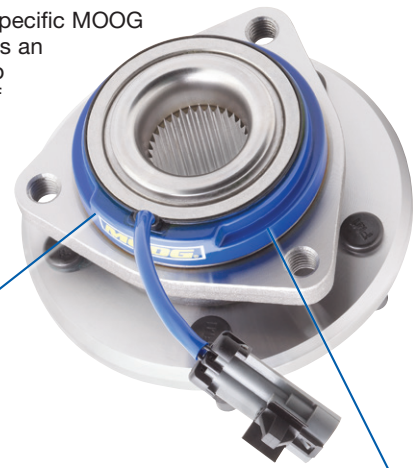
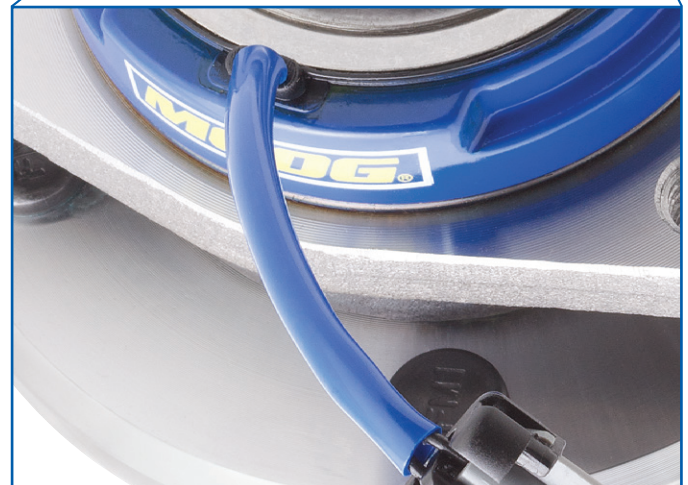
Depending on the application, MOOG® hub assemblies may feature an abrasion-resistant ABS cord that is specially constructed with a blended polyurethane material that provides superior ABS protection, increases abrasion resistance and protects against environmental conditions. This cord – unique to MOOG – is proven to decrease ABS wire failures.

The exclusive application-specific MOOG abrasion material undergoes an intensive 300K-cycle test to validate the performance of its premium formulation versus that of competitors' materials. Test results confirm the MOOG ABS cord's ability to resist severe wear and to remain in working condition without breakage.
